## GM Steering Intermediate Shaft Lube Procedure

This is the procedure for TSB 00-02-35-003D. This problem plagues every full sized GM truck from '99 to '03 ('01 to '03 Suburbans and Tahoes) with the reticulating ball-type steering, I thought this might be helpful.

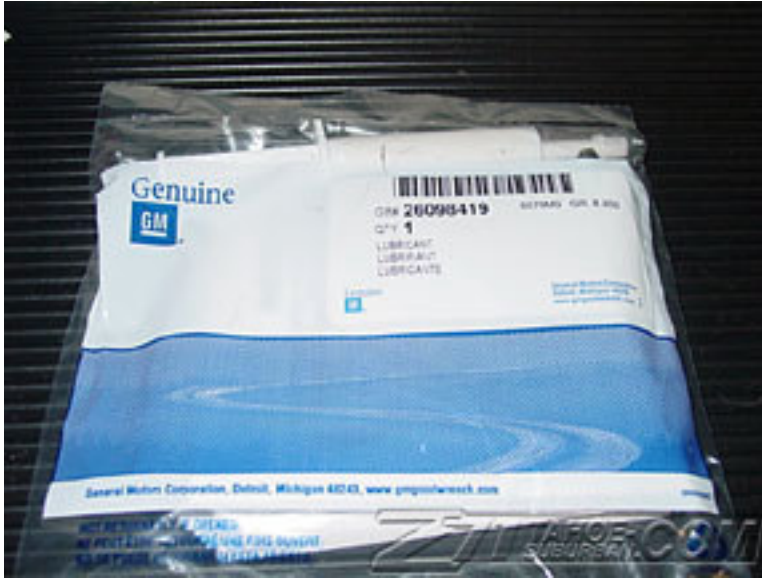
Steering Column Intermediate Shaft Lube Kit GM p/n 26098419

Here are the parts that you will need:

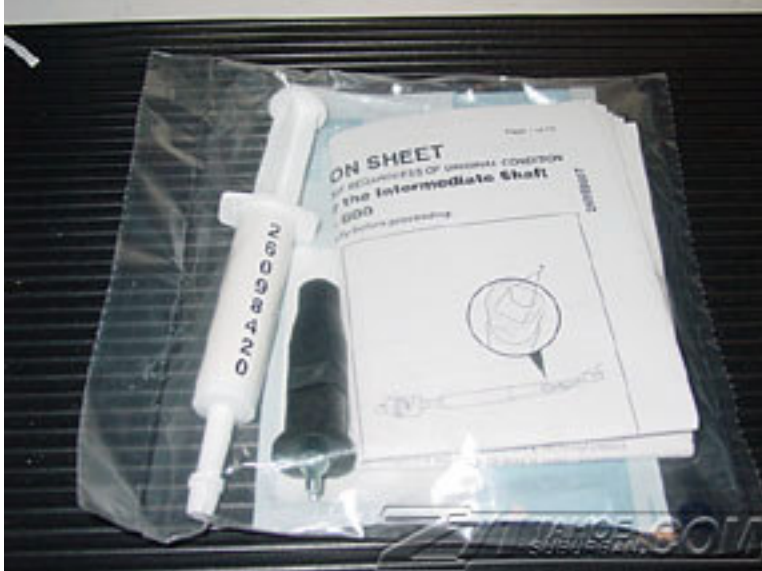
This is the content of the bag:

It comes with the grease tube, a plug, and the instructions.

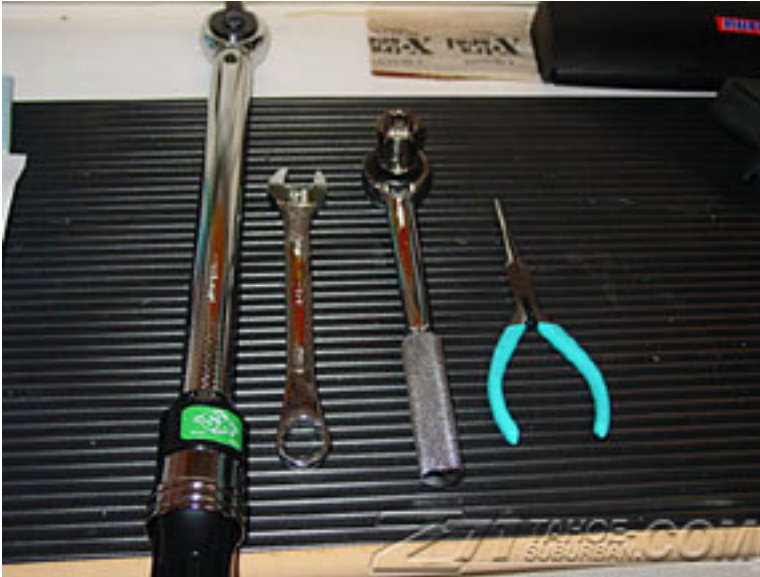
Here are the tools that you will need:

Torque wrench, 2 - 17 mm wrenches (having at least 1 socket wrench will help ease things along), and a pair of needle nose pliers (must have fairly narrow tip to reach inside tube to release clip).

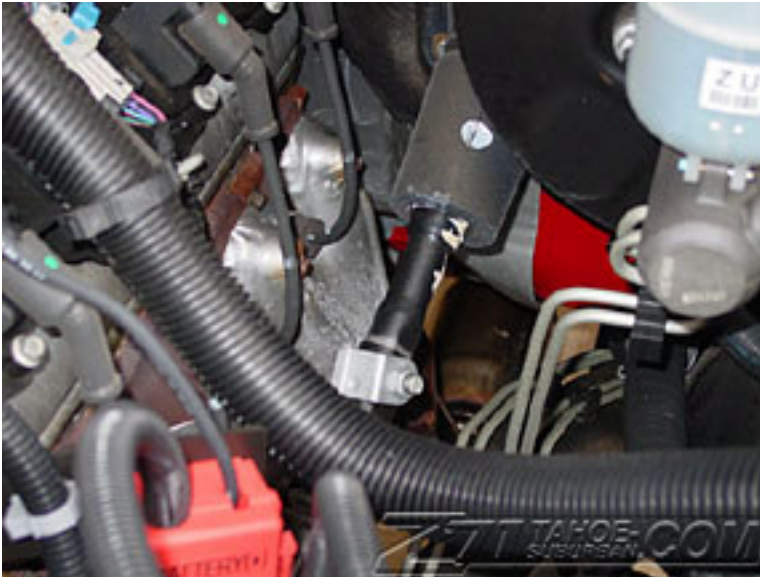
This is the one under the hood.

Once you have the wheel straightened, remove the bolts. You will need the 2-17 mm wrenches to remove the bolt/retainer from under the hood. You will only need one of the 17 mm wrenches to remove the nut from the shaft under the dash. This bolt/retainer has a rounded head. At this point, you would use the J 42640 tool (insert into hole in bottom plastic shroud at the bottom of the steering column--underneath where the shifter is). Once the bolts are removed, disengage the upper shaft by pushing the entire joint towards the firewall.

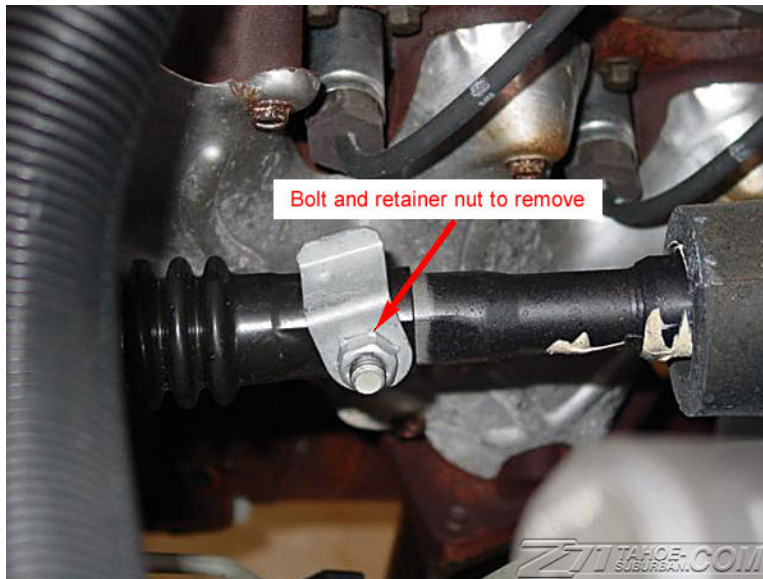
Here is a close-up of the bolt and retainer.

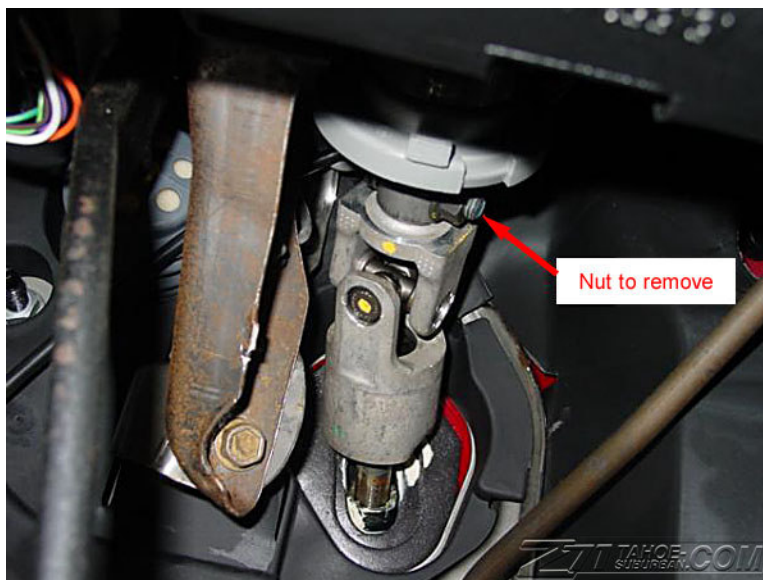
Here is the upper shaft from under the dash.

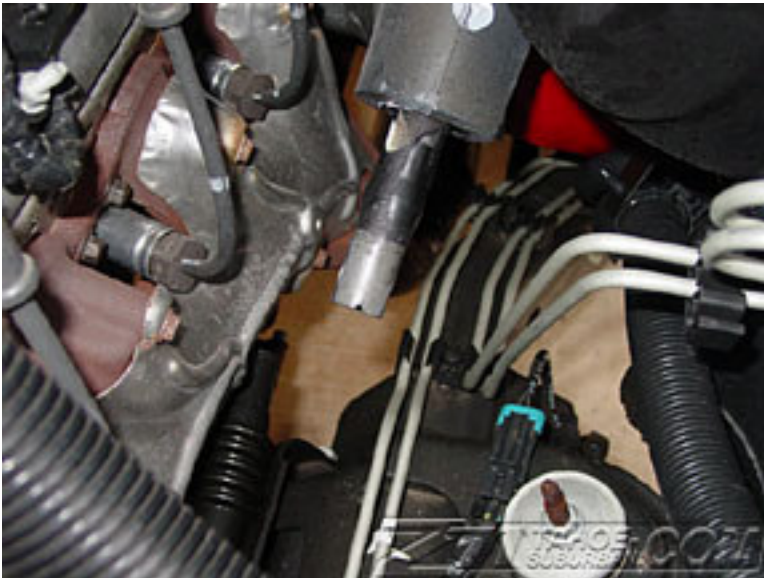
Then disengage the lower shaft by pushing up towards the firewall.

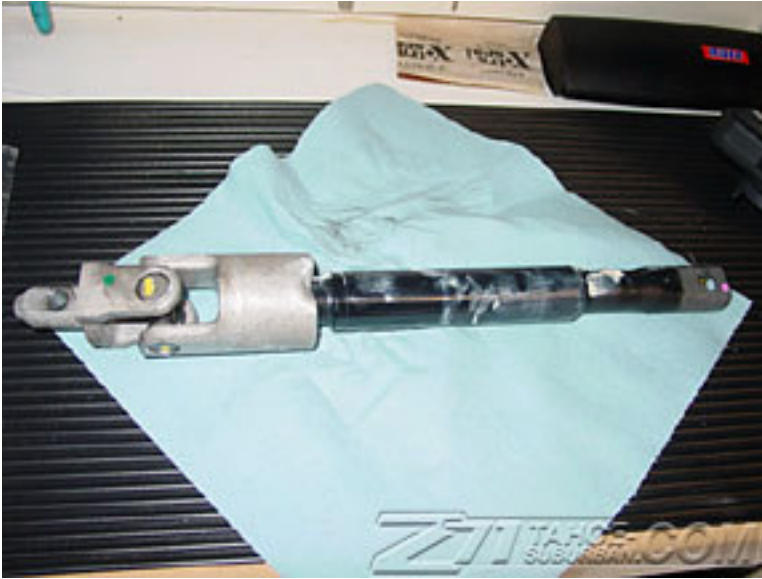
Here is what the entire shaft looks like:

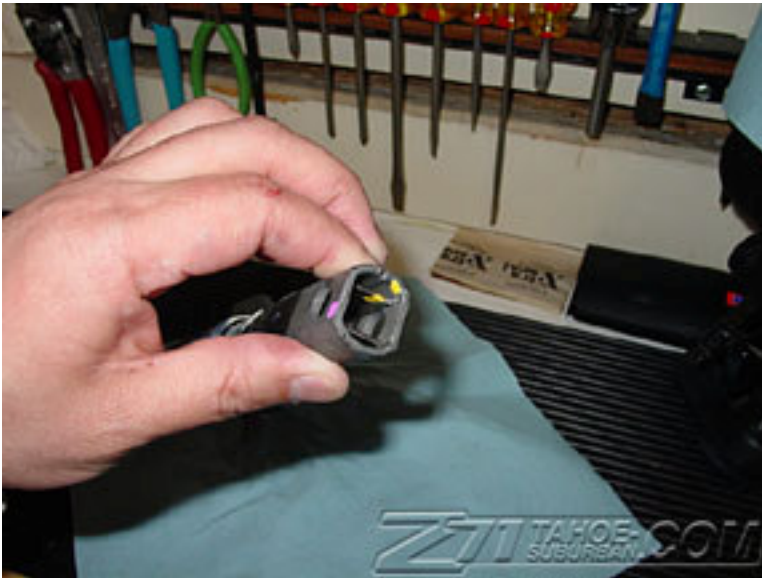
Next, remove the clip the end of the lower shaft with needle nose pliers.

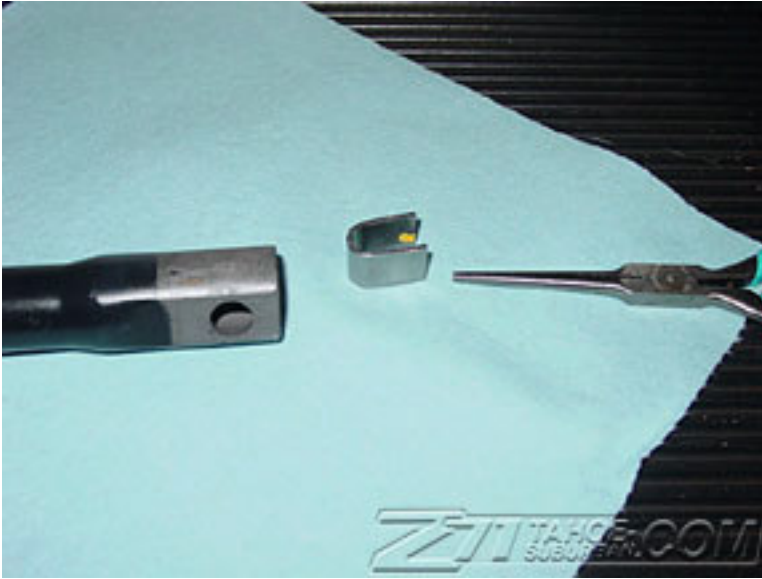
Here is what the clip looks like removed from the shaft.

You are just about done here. Next you have to reinsert the clip back to the open end of the intermediate shaft. The clip may have to be spread if collapsed too much. Just make sure that the clip is not loose in the shaft. The clip should be positioned flush to about 1/4" from the outer lip.

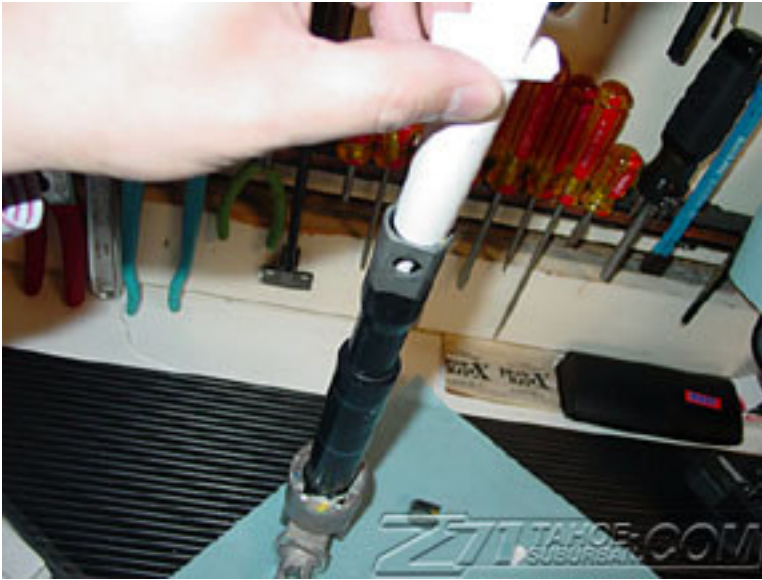
With the shaft, fully extended, there was just a tiny bit of white grease on the shaft. Next, you should inject the entire grease tube from the kit as deep as possible to the fully extended shaft. The grease in the kit is black.

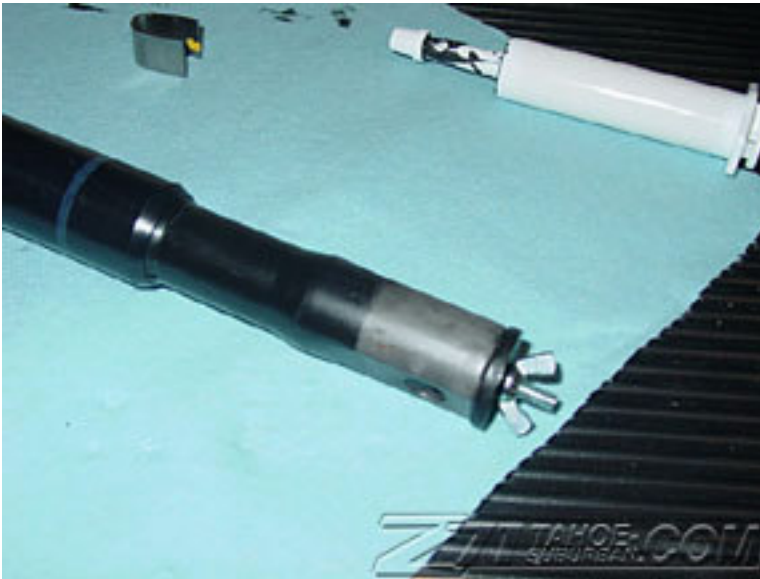
Next insert the plug from the kit into the end of the shaft you just squirted the grease.

Make sure once the plug is in place, tighten the wingnut on the end. This squeezes the sealing ring so that the grease doesn't squirt out in the next step.

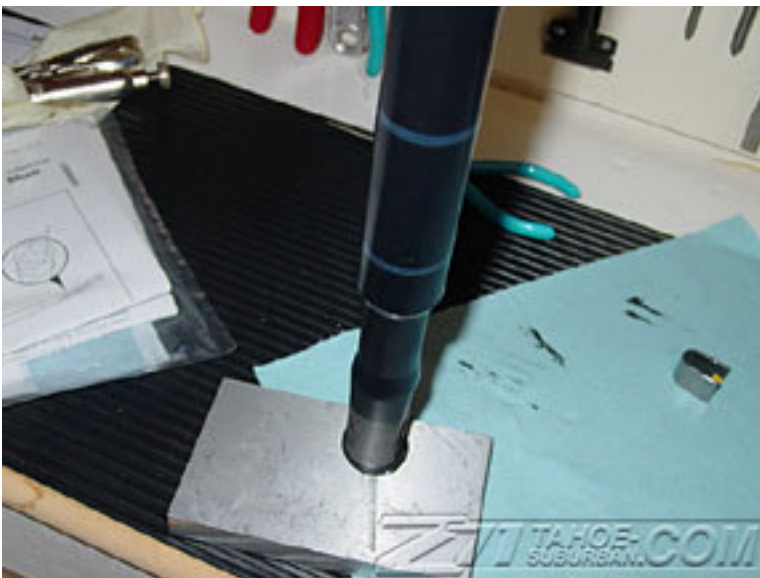
Next, take the shaft and push down on the plug on a hard surface to collapse the shaft. This will force the grease up the splines.

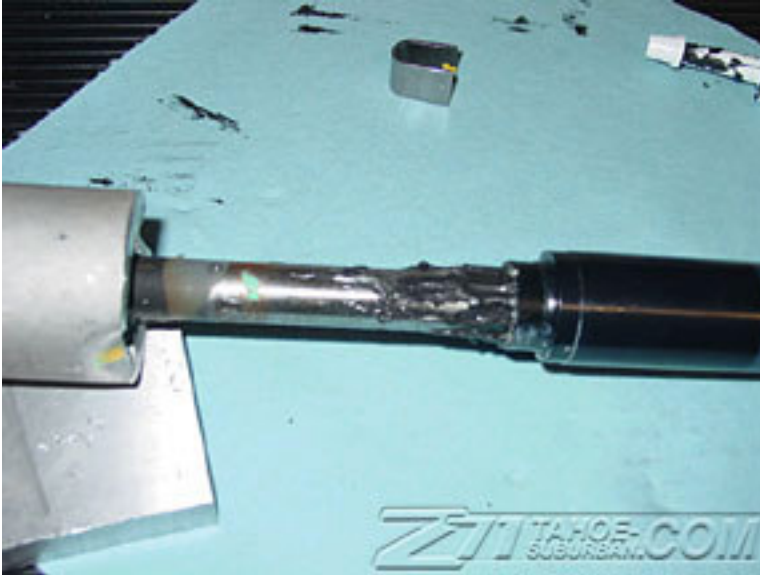
Fully extend the shafts out again. You should have at least 1/2" of grease on the silver shaft.

If you don't have at least 1/2" of grease on the silver shaft, repeat the collapsing of the shaft again until you have at least 1/2" of grease on the silver shaft.
